## ITINERARY IN THE CITY (pp. 15-51).

The Cathedral of Soissons (H.M.) may be considered as a miniature of

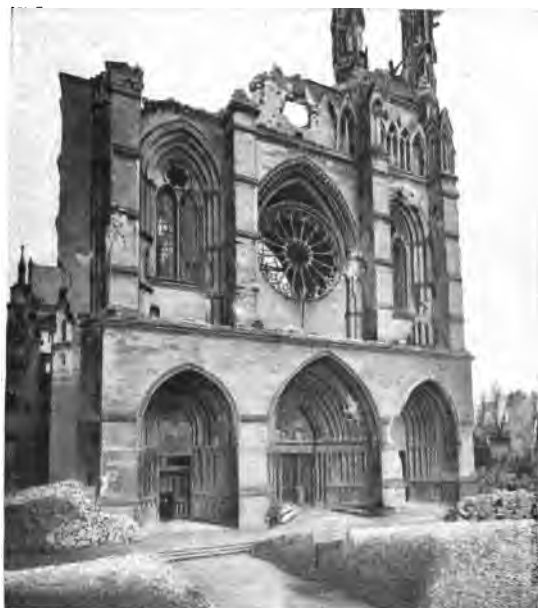
THE  
CATHEDRAL  
IN NOVEMBER  
1918.

The cathedral of Soissons, like that of Arras, has greatly suffered in its vital parts. The nave, which partly fell in during 1915-1916, was, with the aisles, entirely destroyed by the end of 1918. The tower, which, though severely damaged by enemy shell-fire, was still standing, collapsed at the same time. The transept and choir alone escaped with slight damage.

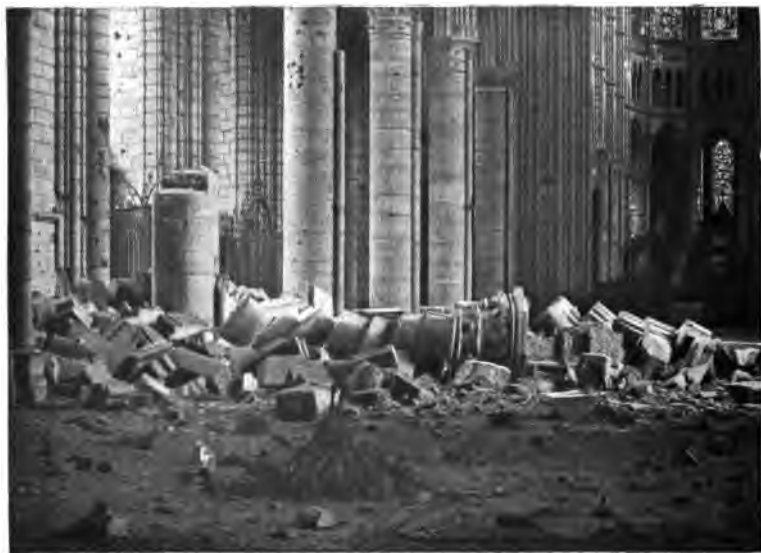
**SOUTHERN AISLE  
AND  
TRIFORIUM,  
NOVEMBER  
1918.**

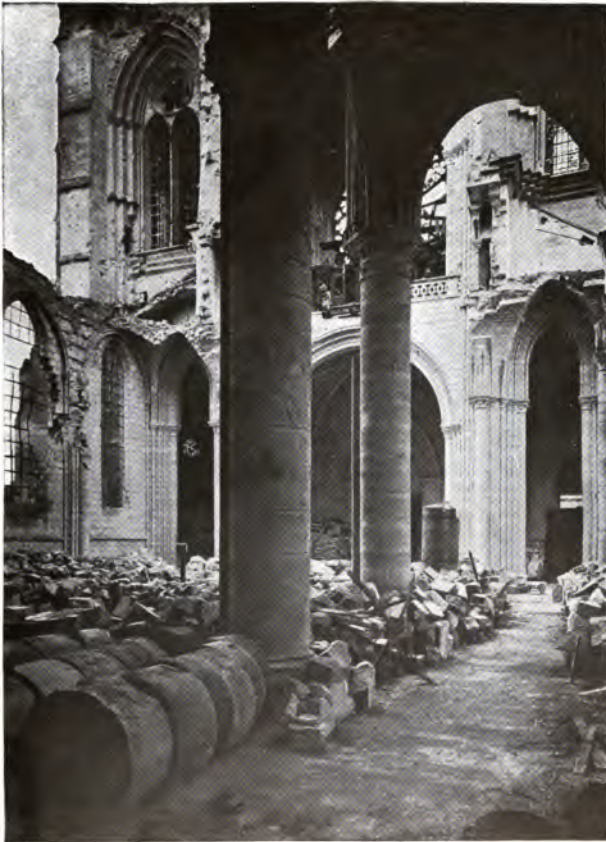
THE GREAT NAVE AND NORTHERN AISLE, NOVEMBER 1918.  
*Behind the two standing pillars is seen the base of the pillar which collapsed in Feb. 1915,  
The wall is shown on p. 20,*

Early in February 1915, a projectile, entering by a hole made by a previous shell in the wall of the south aisle, struck the second column (*A on plan*, p. 18) on the left of the main nave, which was broken in two about 13 feet from the ground (*photos pp. 20-21*). The upper part, with the capital and courses supporting the springing of the vault, gave way, dragging down in its fall a portion of the vault and of the wall at the back of the triforium.

The ruins accumulated rapidly. By the end of March, the roof of the grand nave and of the north aisle, which the broken pillar had sustained, collapsed. The whole of the triforium, the large window, the flying buttress outside, the framework, and the roofing of the bay of the aisle also gave way. An enormous breach was made in the cathedral, and the floor of the nave was covered with a shapeless mass of broken stones, which increased during the following months.

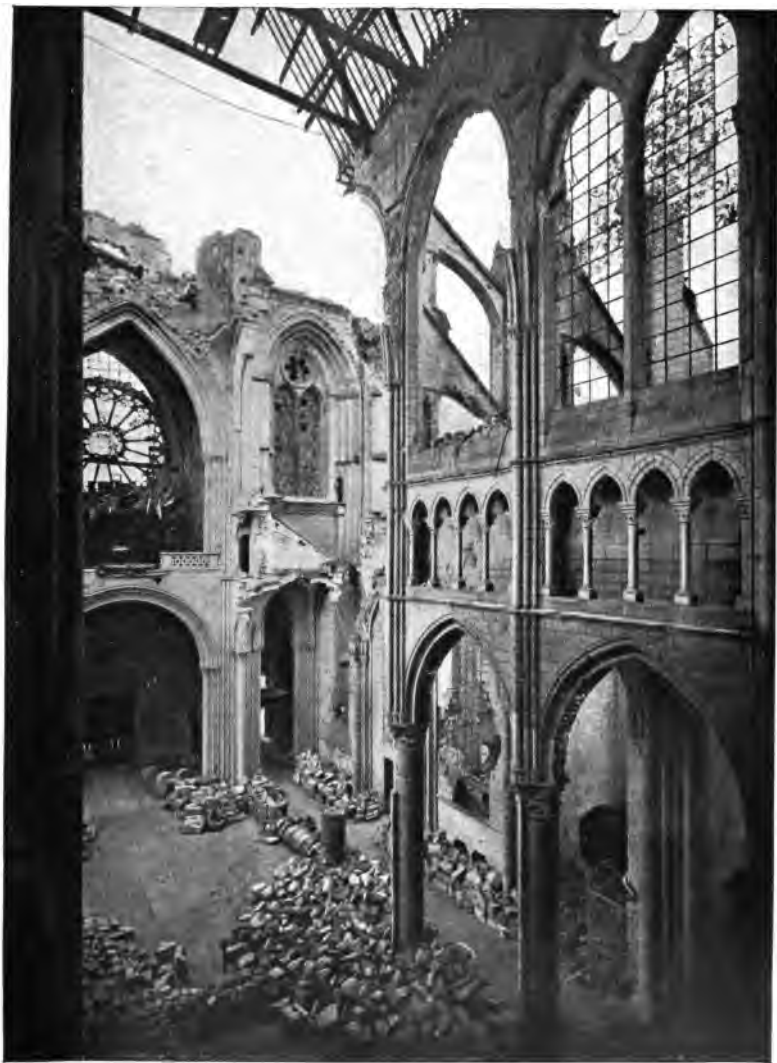
BREACH  
IN THE  
NAVE,  
NOVEMBER  
1918.

The vaults of the remaining bays, already weakened, could not withstand the renewed bombardments. One after another they crashed to the ground, with the exception of those of the first and seventh bays. Everywhere else, pieces of broken or disjointed framework, supporting a completely ruined roof, are exposed to view (*photo above*).

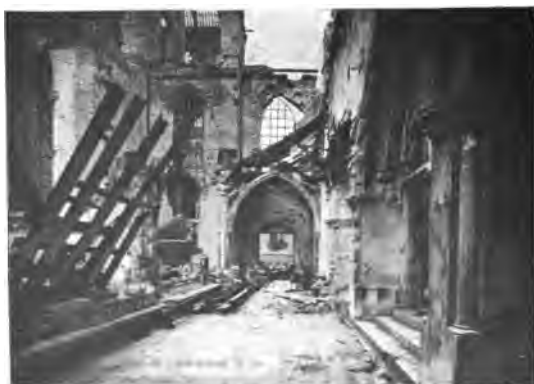
GALLERY  
GIVING  
ACCESS TO THE  
CHAPELLE  
DES ŒUVRES,  
NOV. 1918.

The Chapelle des Œuvres was struck several times. The most serious damage was caused during the first bombardments of 1914 by a shell which exploded on the roof of the gallery (*B on plan p. 18, photo below*) which leads to the chapel. Penetrating the roof and the framework, it caused the vault to fall in, broke the arches, and shattered the stained-glass of the chapel windows.

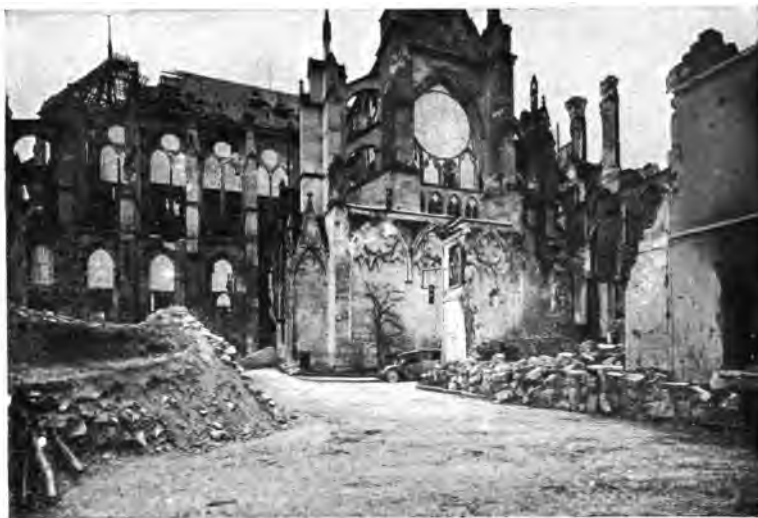
NORTH FRONT. Choir and North Arm of transept, Nov. 1918. See description, p. 29.

The rounded arm of the transept and the south end of the choir suffered comparatively little. On the other hand, the bombardments seriously injured the chevet and the north front of the choir. The upper part of one of the high windows in the apse was struck. A buttress of the Lady Chapel was badly broken, while two unexploded shells are embedded in the damaged stone-work of a neighbouring buttress. On the north front of the choir most of the abutments were damaged and the flying buttresses which support it, more or less in-

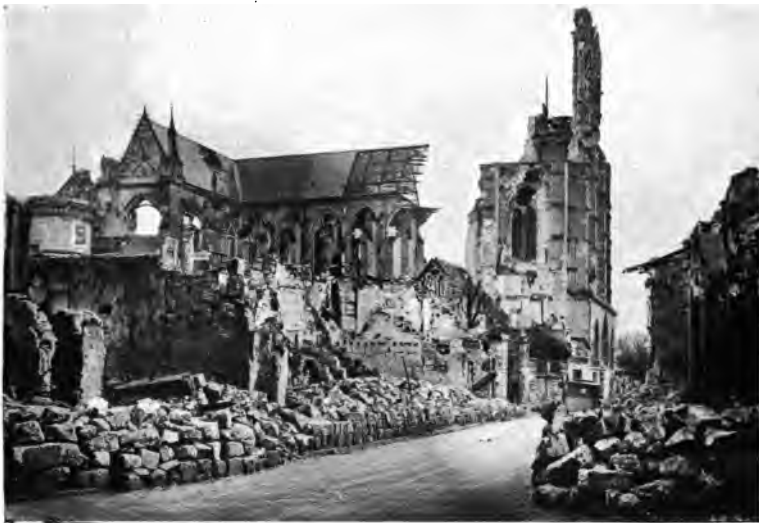
NORTH FRONT. North Arm of Transept, Nave and Chapelle des Œuvres, Nov. 1918.

jured. The roofing was ruined and the framework broken. The north arm of the transept, especially the gable, was also somewhat damaged. One of the turrets surrounding it was broken off (*Photo above*).

However, the north front of the nave suffered most (*photo above*). In addition to the opening made at the west end, the stone-work and roofing were injured throughout their entire length. Only the last two windows next the transept retained their mullions, the others being more or less completely destroyed. Of the flying-buttresses and abutment-piers, very little remains standing.

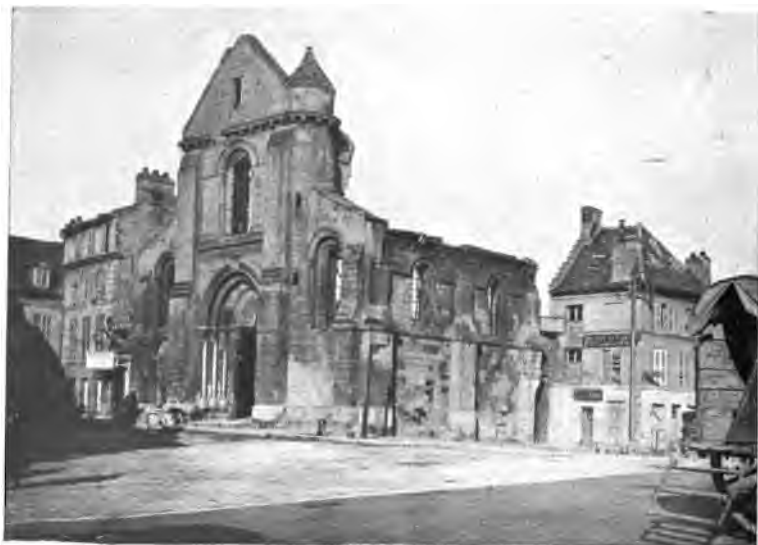
CHURCH OF  
SAINT-PIERRE-  
AU-PARVIS,  
*November  
1918.*

■ The two remaining bays of the nave were greatly damaged during the war by the explosion of a store of grenades. The roof and most of the vaulting have been destroyed.

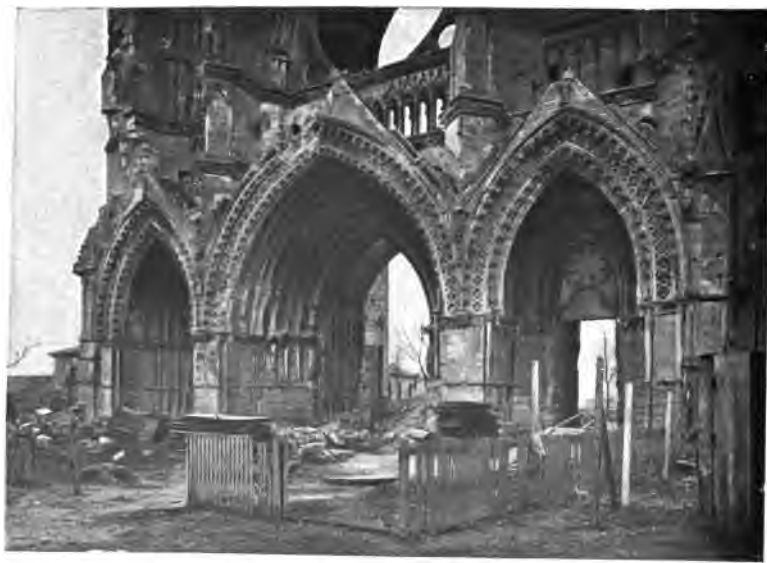
THE DOORWAYS IN THE MAIN FRONT (1918).  
*Part of the ornamental stone-work was damaged by fire in 1870. Keystones of the vaulting  
 were shattered by shell-fire in 1914.*

The damage caused in 1918 was considerably greater. In some places the stone-work of the portals and towers was entirely destroyed, and in others indented more or less deeply. The fine and delicate carvings of the towers were also smashed. The north tower suffered most. A breach, jeopardizing its stability, was made almost the whole way up, and the upper part of the spire fell to the ground, like the other spire had done four years before. The interior vaulting which connected the two towers, partially fell in.

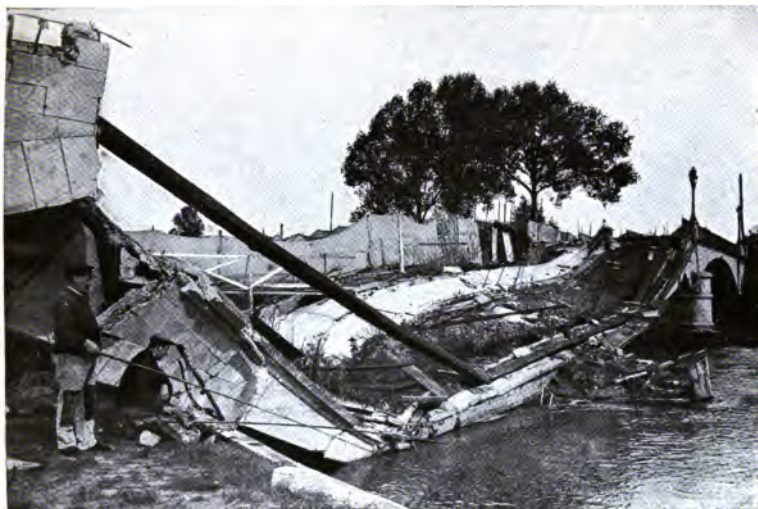
THE  
PONT-NEUF,  
BLOWN UP  
BY THE  
BRITISH.

On September 1, 1914, the British blew up the middle arch. It was subsequently found possible to contrive a crossing over the broken arch, hidden from the view of the enemy by the gaily coloured tents of a travelling show which happened to be in Soissons when war was declared (*photo below*).

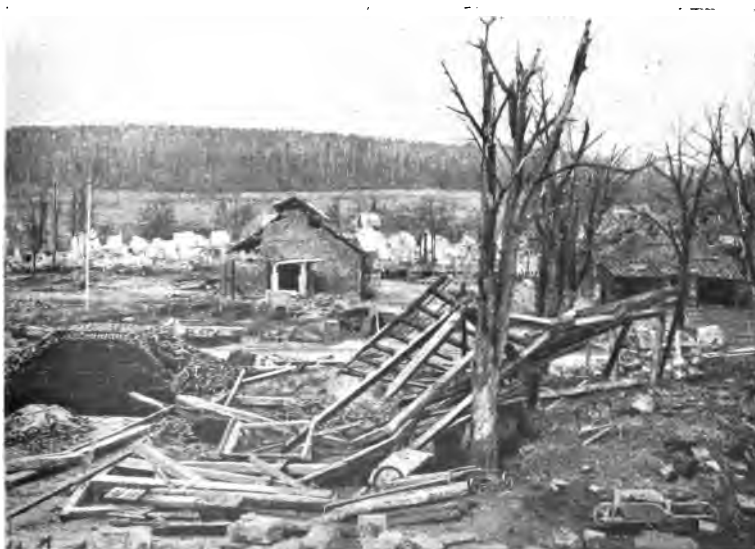
THE  
GLASS-WORKS  
OF VAUXROT.  
In the  
background:  
Hill 136.

Between the buildings of these works, now completely ruined by the incessant bombardments, are countless passages and trenches of reinforced concrete, observation posts, blockhouses, concrete machine-gun positions and deep dug-outs.
